**National Highway  
Traffic Safety  
Administration**

Case Vehicle (A): 1998 Dodge  
 Type: Caravan, 4-door van  
 Driver: 28-year-old female (30 weeks pregnant)  
 CDC: 12-FREW-1

Vehicle (B): 1990 Nissan  
 Type: Pickup, 4x2 regular cab  
 Driver: 53-year-old male  
 CDC: 99-0000-0

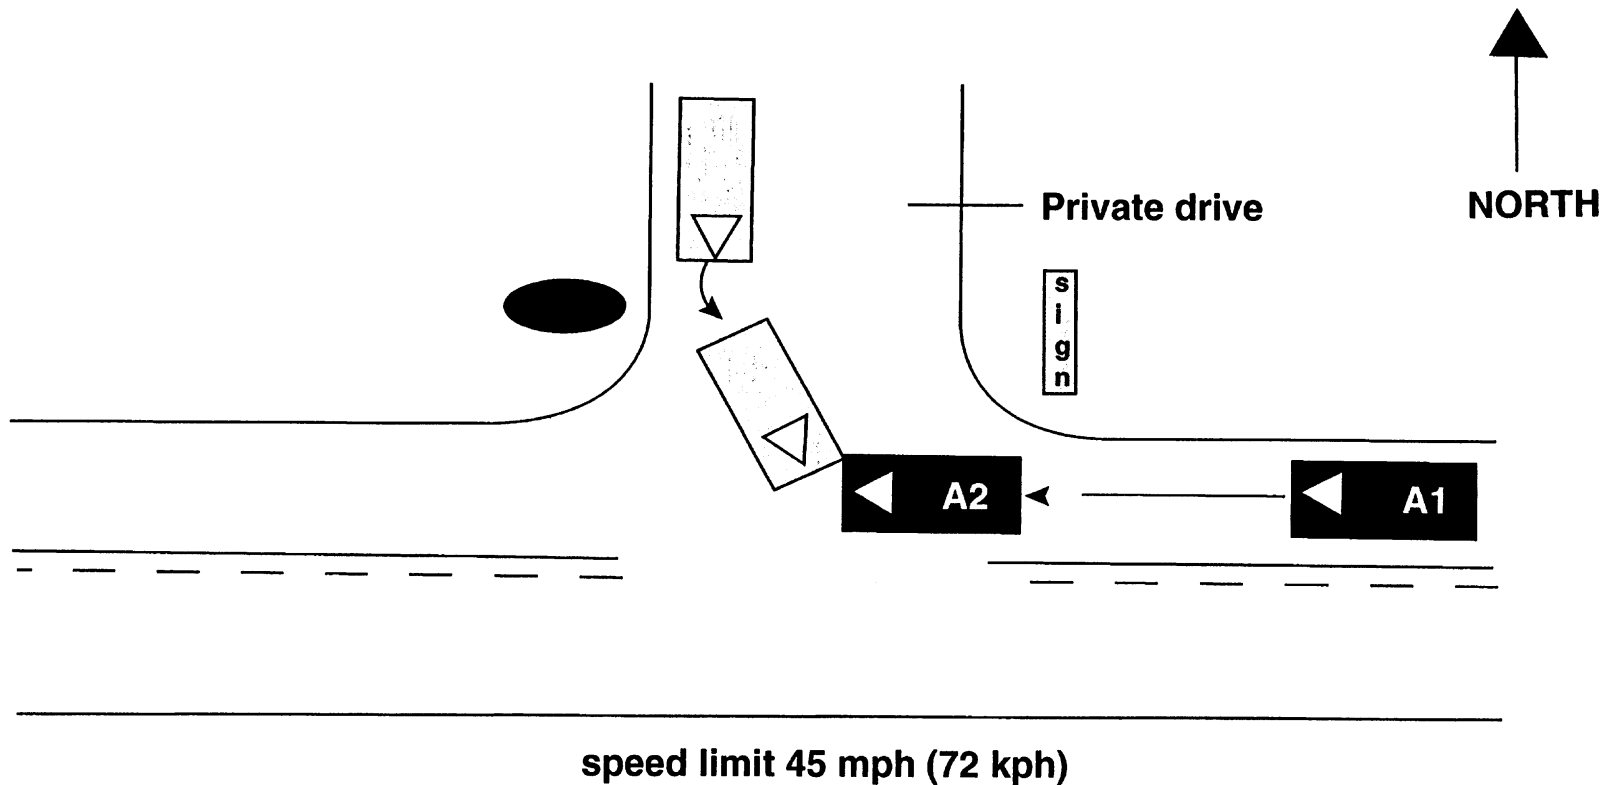
# ACCIDENT SCHEMATIC

ACCIDENT DESCRIPTION: CASE VEHICLE (A) WAS TRAVELING  
WEST AT A DRIVER-ESTIMATED SPEED OF 45 MPH  
(72 KPH). VEHICLE (B) WAS EXITING A PRIVATE  
DRIVE FROM THE NORTH. VEHICLE (B) PULLED FROM THE DRIVEWAY AND  
STRUCK THE RIGHT FRONT OF CASE VEHICLE (A).

(Slides 1, 2) On a cloudy, dry day, case vehicle (A) was traveling west at a driver-estimated speed of 45 mph (72 kph) in the westbound lane of a two-lane asphalt road, in a rural area. Vehicle (B) was stopped facing south in a private drive that intersects with the two-lane road. As case vehicle (A) approached the private drive, vehicle (B) moved out into the intersecting westbound lane and began to make a left turn to travel east. The driver of case vehicle (A) was unable to avoid being struck in the right front by the left front of vehicle (B).

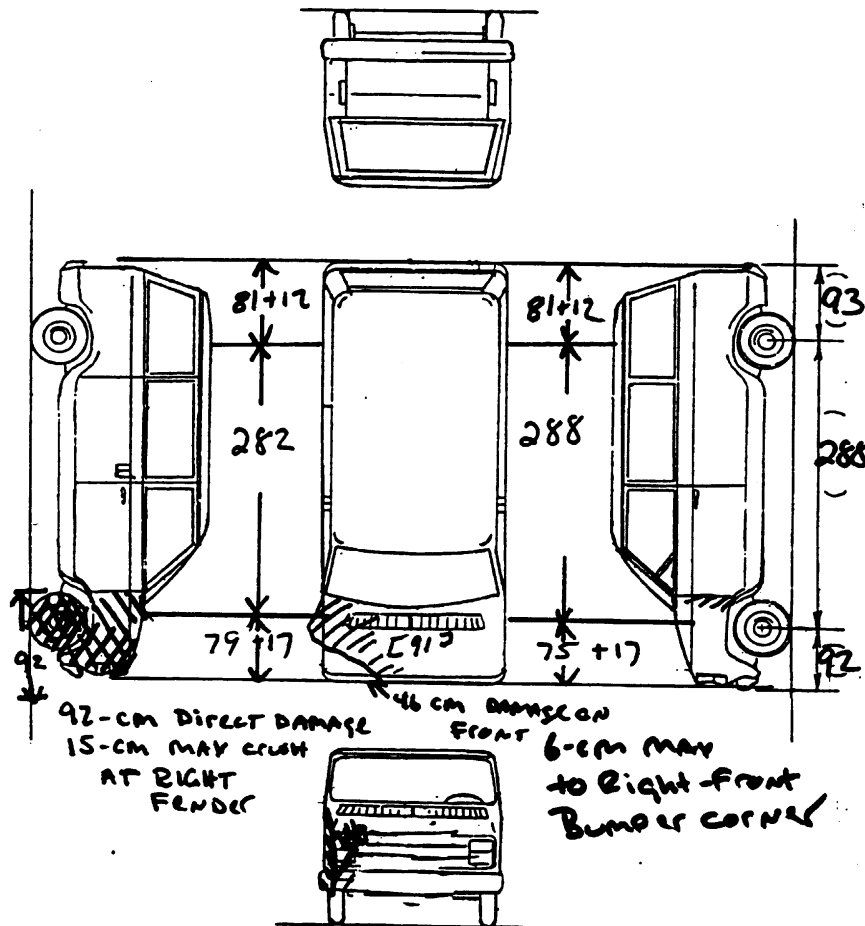
## VEHICLE DAMAGE

Wheelbase	<u>288</u> cm	Front Overhang	<u>092</u> cm
Curb Weight	<u>1601</u> kg	Rear Overhang	<u>093</u> cm
Average Track Width	<u>162</u> cm	Undeformed End Width (UEW)	<u>160</u> cm
Overall Length	<u>473</u> cm	Engine Displacement	<u>3.0</u> L
Overall Width (OAW)	<u>192</u> cm	Engine: # of Cylinders	<u>06</u>

Direct Damage Length (DDL) 0.46 cm

(Slide 3) The direct damage to case vehicle (A) began at the right-front bumper corner and extended 46 cm across the front bumper, resulting in a 32 percent vehicle overlap. The damage also extended 92 cm rearward along the right fender, with a maximum crush of 15 cm. (Slide 4) The maximum crush to the right-front bumper corner was 6 cm.

(Slides 8, 9 and 10) The right fender was crushed, the right turn indicator light was broken, and the right-front wheel was damaged. (Slides 11, 12) The right-front bumper corner was damaged, the right headlight was broken and there was damage to the right side of the hood. (Slide 14) There was no damage to the hood latch or hood hinges, and the rear edge of the hood was not elevated. Also, there was no damage to the windshield. In addition, the right wheelbase was reduced 6 cm. (Slide 13) There was no other damage to the right side and the doors were all operational.

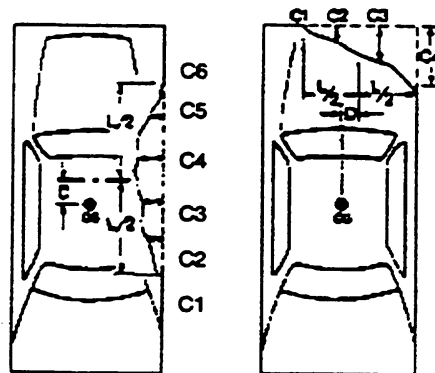
Specific Impact No.	Location of Direct Damage	Location of Field L
1	BEGINS AT RIGHT-FRONT Bumper corner 46-cm	BC to BC

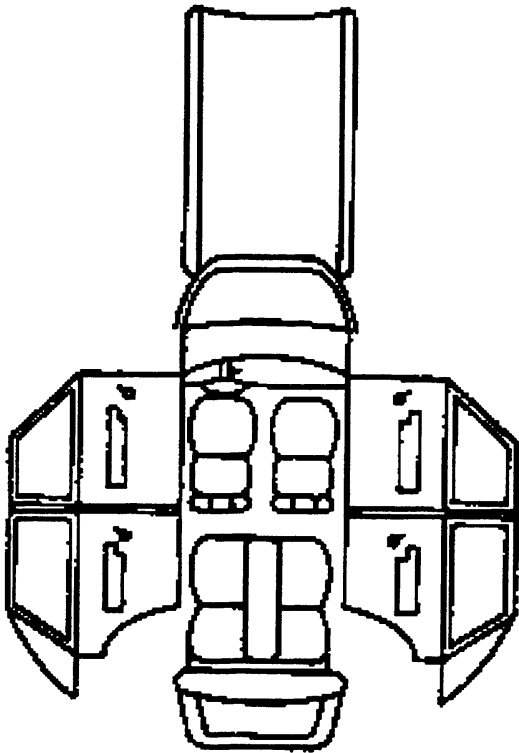
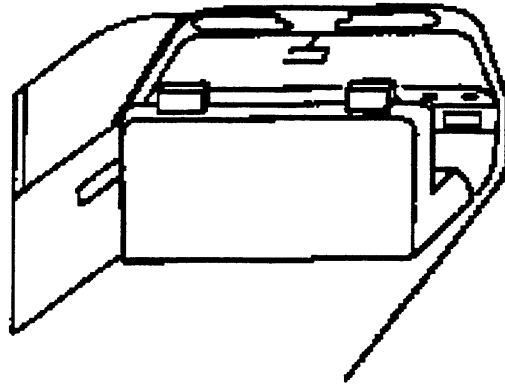
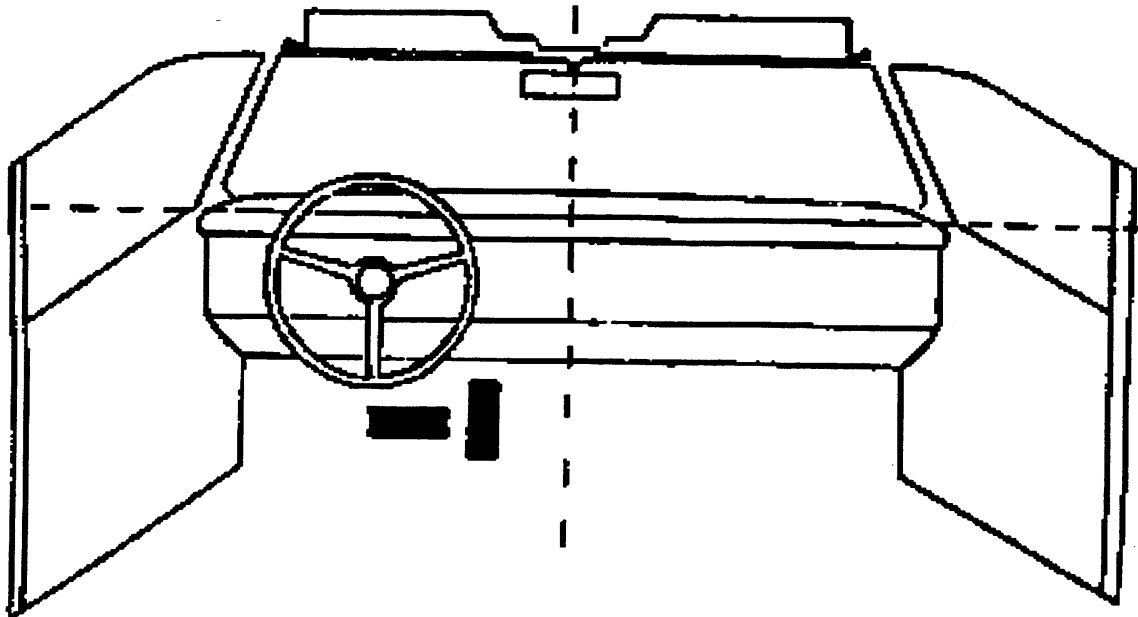
## VEHICLE OCCUPANT CONTACT DIAGRAM

DR BELT: LOW ADJUST ON  
B-PILLAR

BELT EVIDENCE: COVER OVER  
B-PILLAR IS CRACKED  
GREY PLASTIC TRANSFERS  
ON BELT WEBBING FROM  
PLASTIC GUIDE ON B-PILLAR

(Slide 30) The 5-ft, 8-in, 250-lb female driver was 30 weeks pregnant with twins. (Slides 31, 32, 33, 34, 35 and 36) She was wearing the available three-point belt, as evidenced by gray plastic marks on the shoulder-belt webbing from the plastic guide on the B-pillar, and the fact that the cover over the B-pillar was damaged. The steering-wheel frontal-impact airbag also deployed during this crash. (Slide 37) The shoulder-belt anchor point was adjusted to the lowest position on the B-pillar, and the driver reportedly had the seat adjusted to a rear-track position. She did not report any problems wearing the belt due to her pregnancy. She also had the steering-wheel in the full-up position due to her large pregnant abdomen, and she had her hands on the steering wheel at the 10 and 2 o'clock positions. She reportedly did not have time to apply the brakes before the impact.
